Sludge deposition and caustic embrittlement in the pre-mature failure of a waste heat boiler steel plate

D.J. Simbi and O.S. Chinyamakobvu*

Department of Metallurgical Engineering, University of Zimbabwe,
P.O. Box MP 167, Mount Pleasant, Harare, Zimbabwe.

A failure investigation of a welded waste heat boiler steel shell that developed transverse cracks was carried out in 1996 to determine the cause of failure as well as propose measures to be adopted to prevent similar failures occurring in the future. The boiler had been in service for several years before two cracks across two traversing circumferential welds were discovered on the underside during routine inspection. Chemical and metallographic analyses indicated that the boiler plate was made from a conventional C-Mn steel and that it was certainly suitable for the purpose. The boiler interior showed massive deposition of a calcareous sludge on the walls and tube bundles. This was attributed to an excessive use of sodium orthophosphate to reduce the hardness of the boiler feed water. The high levels of Na^+ and PO_4^{3-} ions found in both the sludge and boiler feed water analyses were taken as confirmatory evidence. Feed wa

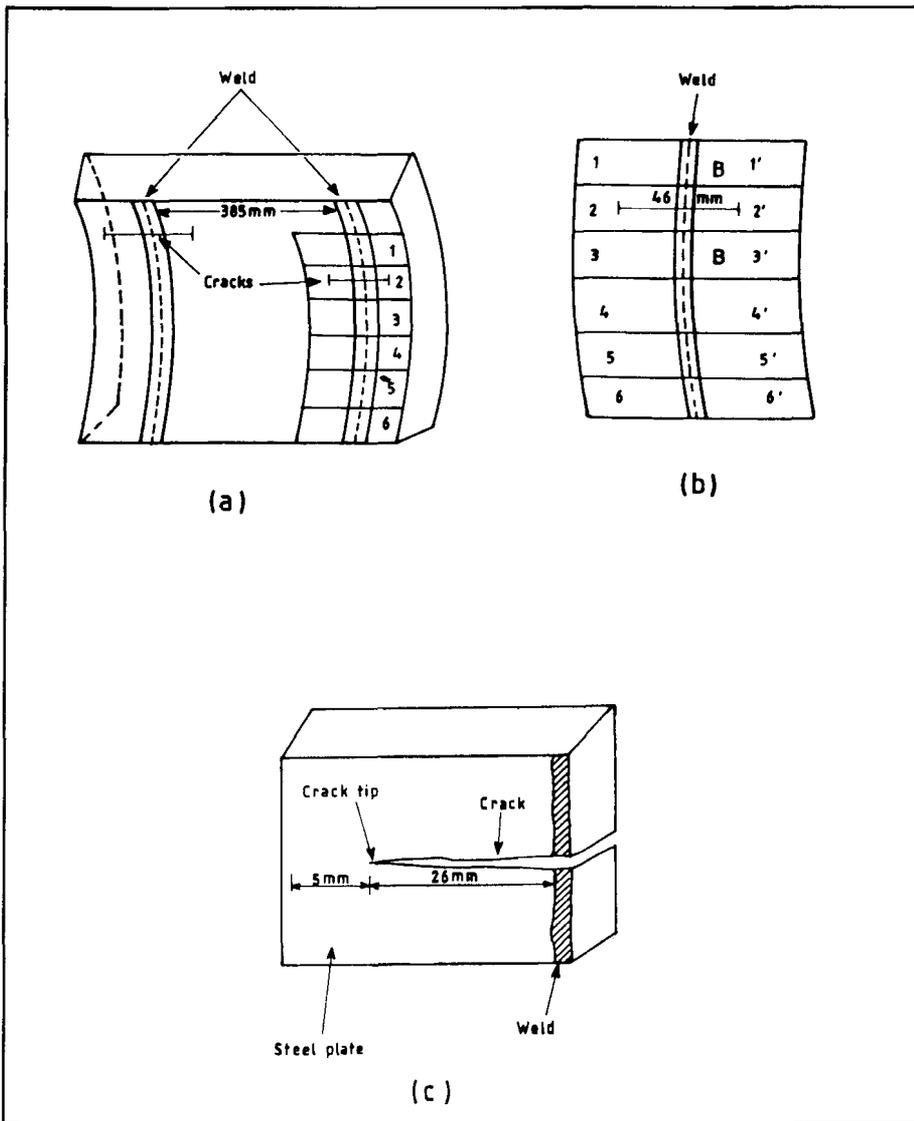
Figure 1: Schematic representation of the boiler steel plate showing:

A welded steel plate containing the cracks was cut from the underside position of a waste heat boiler steel shell that developed transverse cracks across circumferential welds. A schematic representation of the positions of cracks with respect to the circumferential welds is shown in Figure 1a. A section containing the 46 mm long crack was cut into six segments and these were further subdivided into two along the weld (Figure 1b). The chemical composition of steel plate used to fabricate the boiler shell was determined quantitatively by spectrographic technique using a specimen labelled segment 1' (Figure 1b) in which the weldment and base metal were both present. The analysis obtained is given in Table 1.

- (a) dimensions and position of two transverse cracks relative to the two circumferential welds.
- (b) section with the shorter of the two cracks sub-divided into six segments.
- (c) segment used in microhardness profile determination (see Figure 5).

A close examination of the surface after removing the magnetite did not reveal features characteristic of general corrosion. The two cracks previously observed on the outside were also identified on the water-side after removing the calcareous sludge and magnetite scale/film. This provided clear evidence that through cracking of the steel plate across both welds had occurred.

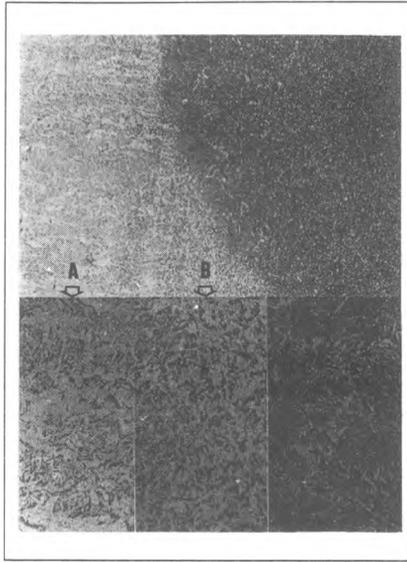
Plate 1: Microstructure of the weld/base metal interface. x100

Examination of the weld/base metal interface, that is, the weld fusion zone in the unetched condition (see segments 1', 3' to 16' in Figure 1b) did not reveal the presence of such defects as slag inclusions or pores indicating that good welding practice had been followed. After etching the specimens in 2 percent nital solution, two different microstructures were, however, observed. These comprised 'white' or 'light' and 'dark' zones (Plate 1). When both zones were viewed at high magnifications, the 'white' zone was found to consist of columnar and equiaxed grains labelled A and B, respectively. The dark zone marked C in Plate 1 shows the microstructure to be martensite. In contrast, the base metal away from the weld fusion zone had a pearlite-ferrite microstructure with some of the pearlite appearing in clusters (Plate 2). It is most probable that in the dark zone of the weld/base metal interface, the pearlite was transformed into martensite/bainite, which is inherently brittle unless tempered. Microhardness measurements taken of these structures showed the following trends: 'white' zone, 213 to 219 HV and 'dark' zone, 234 to 253 HV. Plates 3 and 4 show the section of the crack previously identified as segment 2' (Figure 1b) viewed from the water-side in the unetched and etched conditions, respectively. Several cracks branching from the main crack can be seen (Plate 3). Blunting of the main crack tip is also evident. The mode of cracking appears to predominantly intergranular (Plate 4). The observation of intergranular separation in the microstructure reported suggests the possible involvement of caustic embrittlement in the cracking process, a point that will be discussed later in the light of the chemistry of the sludge and boiler feed water.

- (i) White zone: A — columnar and B — equiaxed grains. x200
- (ii) Dark zone: C — martensite. x200

Cracking which occurred on the underside was probably initiated by a simple combination of existing residual stresses and normal operational conditions from underneath a porous calcareous sludge deposit. Stress relieving after welding is advisable in order to avoid excessive residual stresses around the weld.

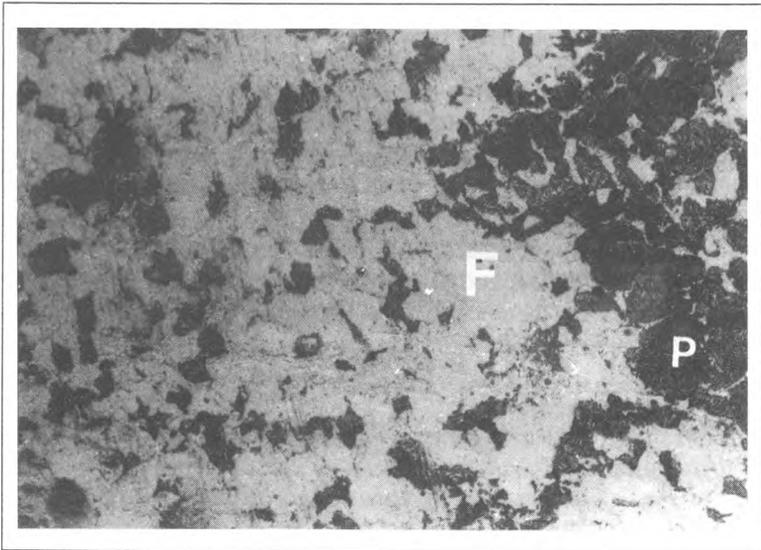
Plate 2: Microstructure of the base steel plate away from the weld. x100

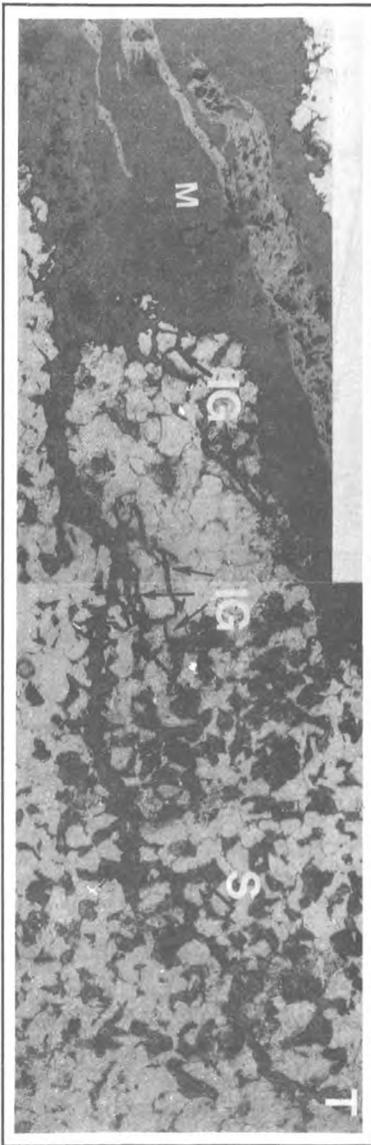
Plate 3: A section of the segment designated 2' in Figure 3b viewed from the waterside in the unetched condition showing: M-main crack; B and C-branching cracks; blunt crack tip. x100

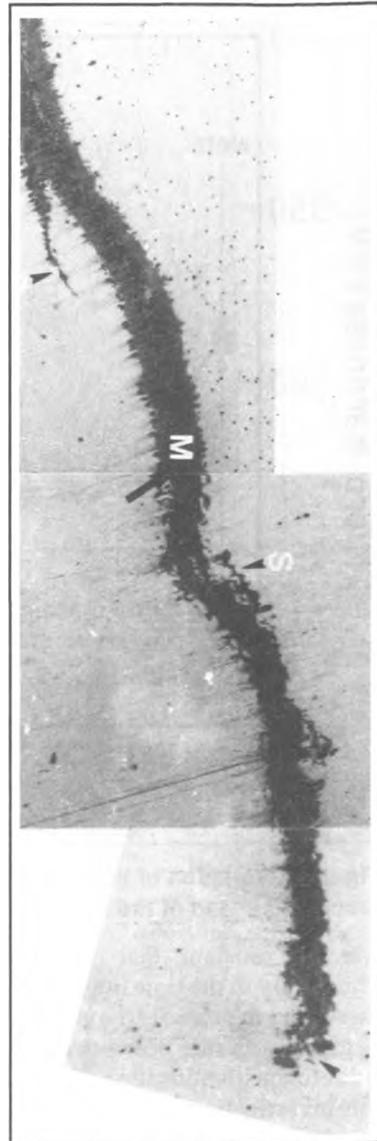
Plate 4: Microstructure of the main branching crack described in Figure 6 showing intergranular separation, S. x200

to over 200 000 ppm in the pores of the deposit adjacent to the boiler wall surface. In caustic embrittlement, crack propagation is generally intergranular. In the present investigation, high pH and caustic alkalinity reported in the period prior to the discovery of the two transverse cracks point strongly to the involvement of caustic embrittlement in the cracking process. The observation of intergranular separation in the microstructures adjacent to the crack paths provides further confirmation of the suggested failure mechanism.

That caustic embrittlement appears most plausible as the cause of failure is supported by observation of intergranular features in the microstructures. Furthermore, the C-Mn steel which was used to fabricate the boiler shell is known to be susceptible to caustic cracking, particularly at elevated temperatures such as those encountered in waste heat boilers.

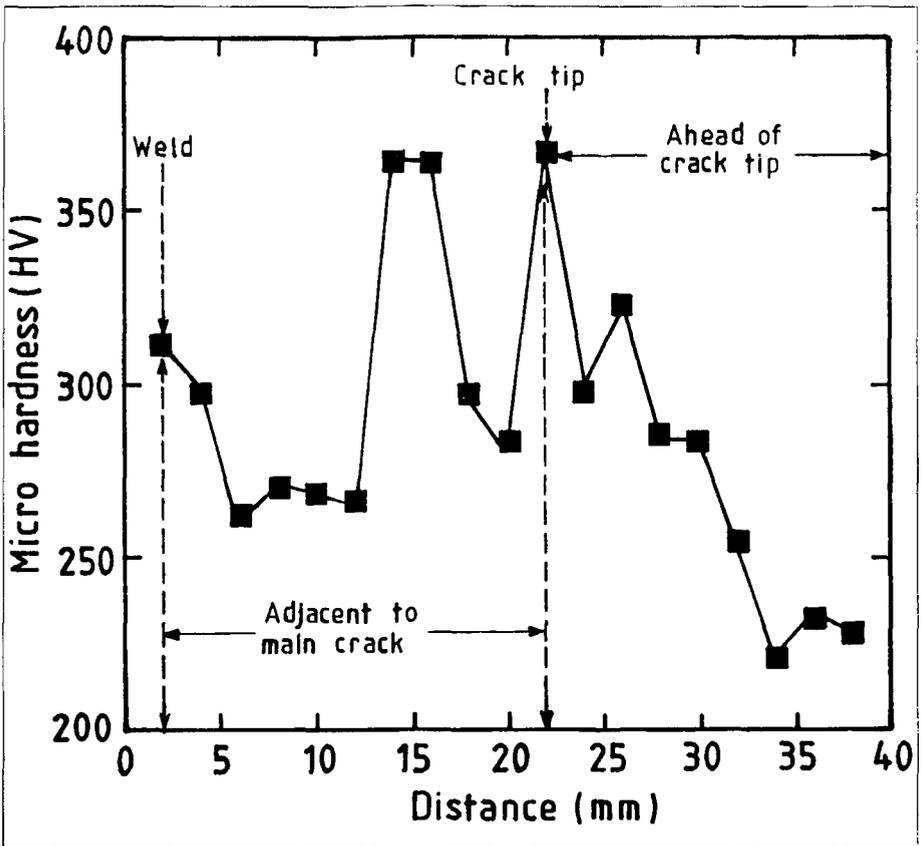
Microhardness measurements taken on the segment identified as 2 in Figure 1b show the hardness values adjacent the main crack path ranging between 254 and 363 HV. A plot of the Vickers hardness, HV, versus distance from the weld to a point ahead of the crack tip is shown in Figure 2. The higher peaks in the curve were found to correspond to areas where there was a relatively high density of pearlite structures in the area in or adjacent to the crack path. Ahead of the crack tip, the hardness was found to drop rather rapidly down to a value of approximately 225 HV as the distance from the crack tip was increased. This value is in agreement with the general hardness of 220 HV for this material as reported earlier.

Figure 2: Variation of Vickers microhardness with distance adjacent the main crack and ahead of the crack tip.

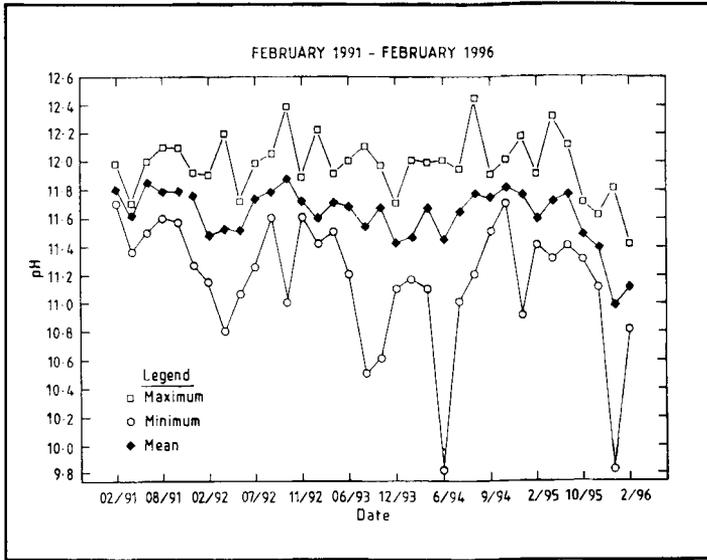
was not constant, that is, it varied from three to seven months. The lack of uniformity in the time intervals between plotted readings makes it difficult to use these data to properly monitor boiler feed water quality. This obviously affects the degree of accuracy of any corrective measures likely to have been taken. The period prior to the identification of the cracking problem which seems most significant in this investigation lies between June 1994 and February 1996. An analysis of the pH graph during this period, for example, shows that the latter was generally maintained on the high side with maximum values of around 12.4 being reported (Figure 3). A pH range of 8 to 11 is suggested in the literature [Brown, 1971]. The optimum pH level for a system which is established by experience for each installation is the level that keeps amounts of corrosion products of iron in the boiler at a minimum. However, with inadequate water treatment practice or lax pH control, there is potential for excessive water-side corrosion, in particular on boiler tube surfaces.

Figure 3: Variation of boiler feed water pH during the period February 1991 to February 1996.

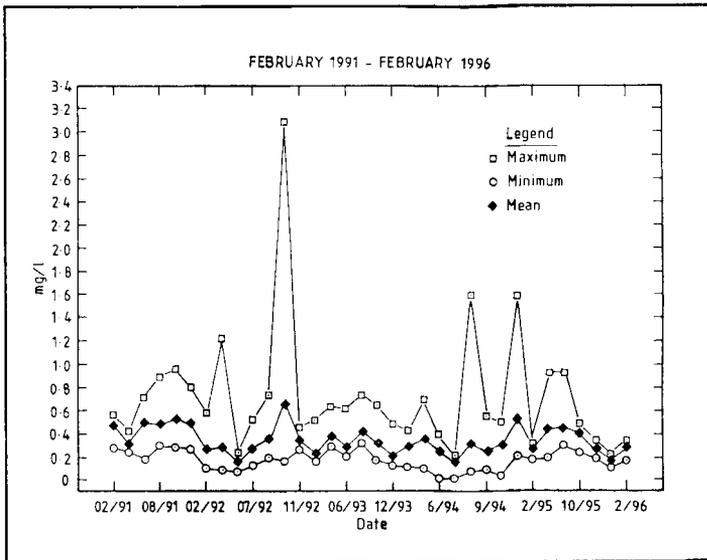
Figure 4: Variation of boiler feed water caustic alkalinity during the period February 1991 to February 1996.

The corresponding alkalinity, chloride and phosphate values (Figures 4 to 6) for the period under consideration were within acceptable ranges. Conductivity and total dissolved solids on the other hand were generally on the high side (Figures 7 and 8).

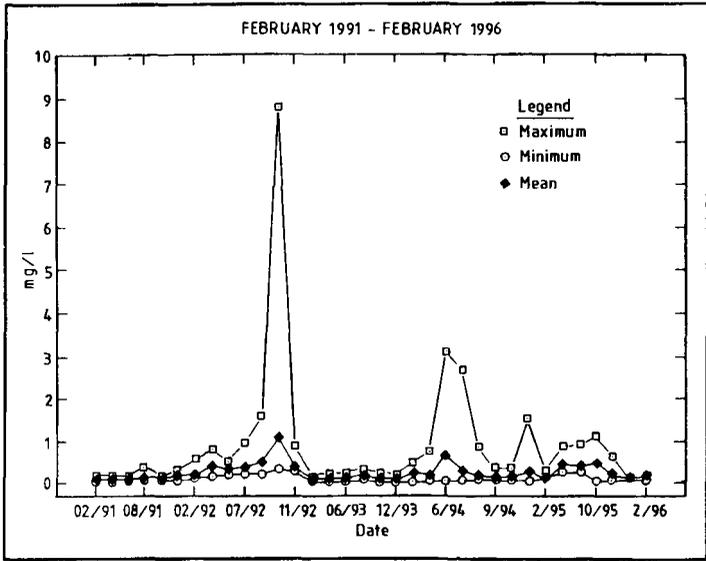
Figure 5: Variation of boiler feed water chloride content during the period February 1991 to February 1996.

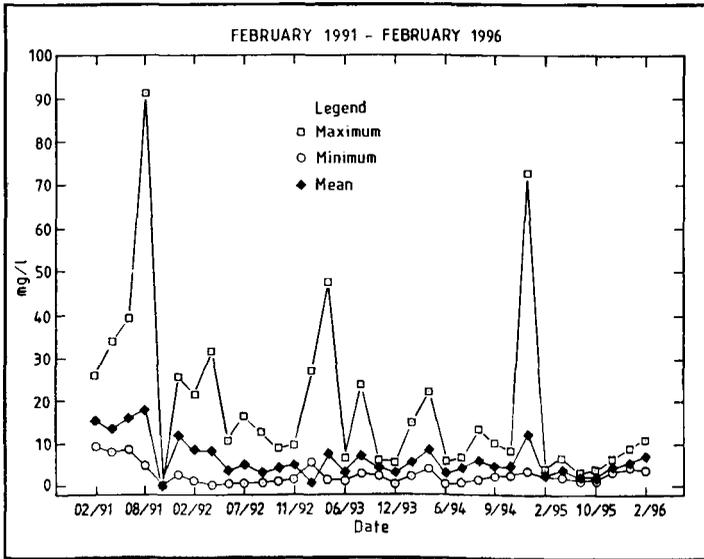
Figure 6: Variation of boiler feed water phosphate content during the period February 1991 to February 1996.

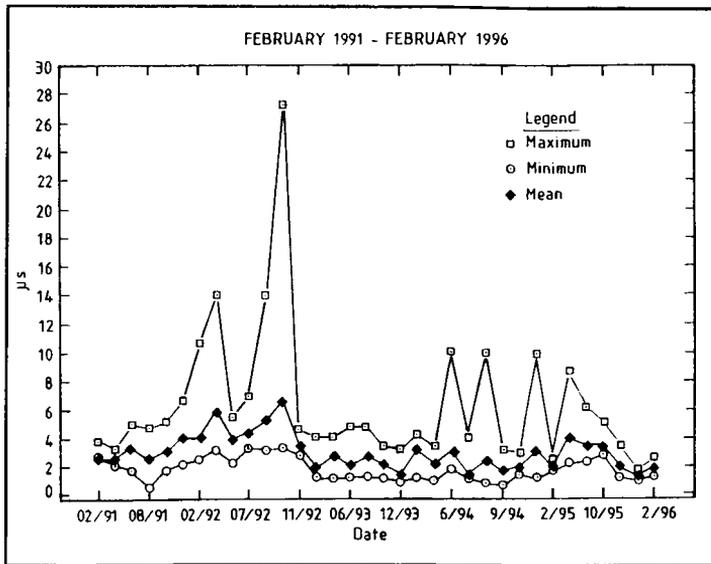
Figure 7: Variation of boiler feed water conductivity during the period February 1991 to February 1996.

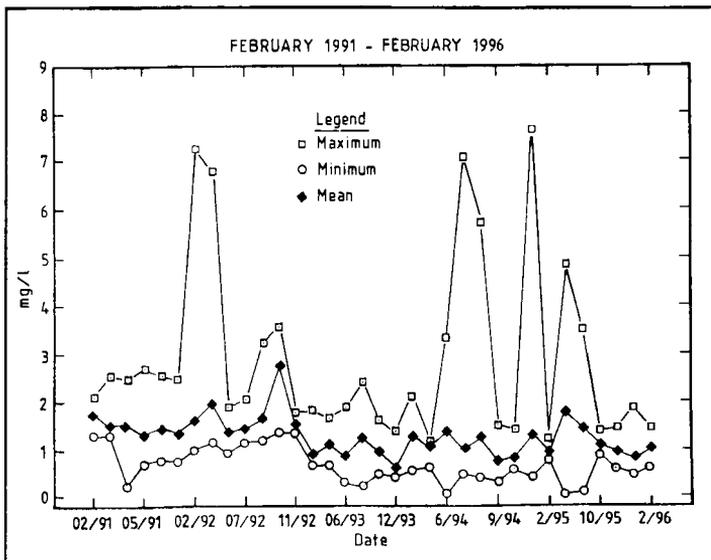
Figure 8: Variation of boiler feed water total dissolved solids during the period February 1991 to February 1996.
