**The Journal of the
University of Zimbabwe**

GULLY FORM AND DEVELOPMENT ON KAROO SEDIMENTS IN CENTRAL ZIMBABWE: A PRELIMINARY SURVEY

R. WHITLOW

C. FIRTH

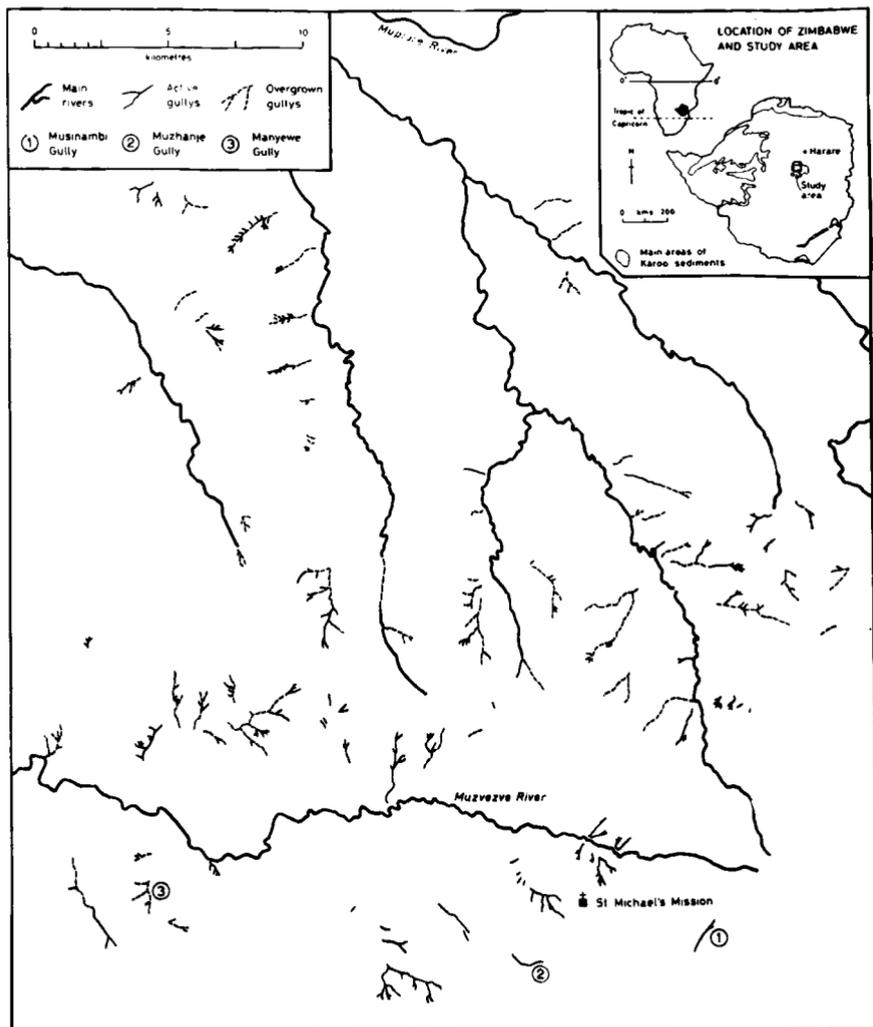
Figure 1: DISTRIBUTION OF ACTIVE AND STABILIZED GULLIES ON KAROO SEDIMENTS IN CENTRAL ZIMBABWE

half of the area underlain by Karoo sediments (Fig. 1 inset). More detailed mapping of this western area was carried out using 1:50 000 topographical base maps and 1:25 000 aerial photographs taken in 1976. The results of the survey are presented in Figure 1.

A total of 116 gullies or gully segments (where active and stabilized channels were linked) were identified, of which 62 appear to be active and the remainder

Three general observations can be made regarding the distribution of the gullies. Firstly, although active gullies occur throughout the area they are especially common in the upper reaches of the Muzveze River. Here gully density is around 237 m per km² — over five times that for active gullies elsewhere in the study area. Secondly, stabilized gullies are prevalent in the lower reaches of the river along with the gullies draining into the northward flowing tributaries of the Mupfure River. Thirdly, there are several gullies where the lower portions of the incised channels are now vegetated and stabilized but where the upper portions are still devoid of plant cover and apparently actively eroding. The reasons for these differences are not known as yet but may relate to variations in the nature of the Karoo sediments and rejuvenation of the major river systems.

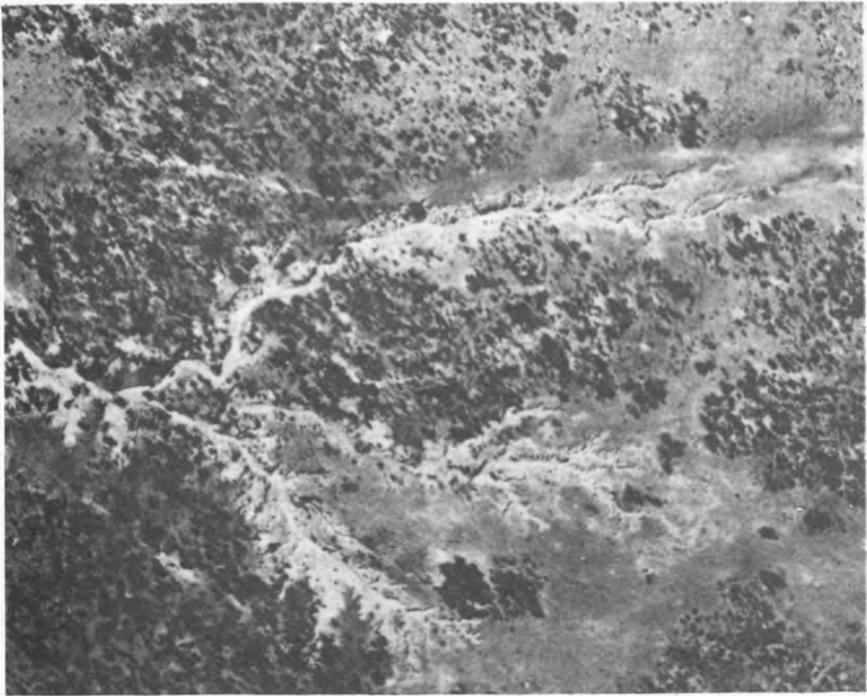
Plate 1: DENDRITIC GULLY SYSTEM 1:12 500

Generally, the active gullies in this area are 'Type 3 gullies' as defined by Imeson and Kwaad (1980); that is, they have U-shaped cross-sections, are formed in colluvial or weathered materials and are characterized by subsurface piping due to the influence of high levels of exchange sodium. Although the gullies are typically dendritic in form (Plate 1), at least three other types are present. Firstly, at least 7 of the 62 active gullies have a compound form (Plate 2; Ireland *et al.*, 1939). This gully form is believed to represent an advanced stage in the degradation of a dendritic system whereby tunnelling between adjacent headcuts results in the formation of residual ridges and the opening out of the gullies as

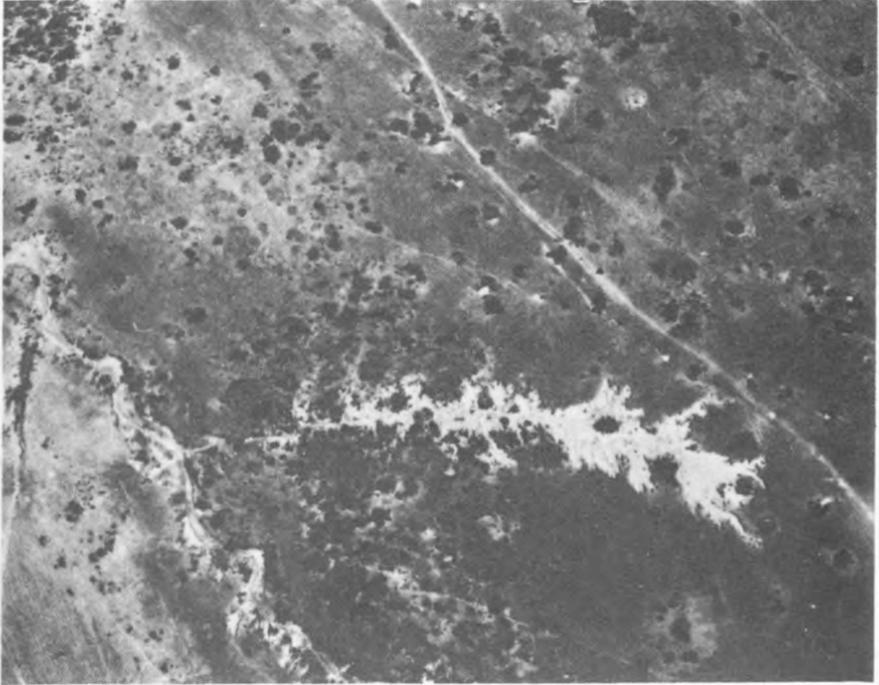
Plate 2: COMPOUND GULLY SYSTEM 1:12 500

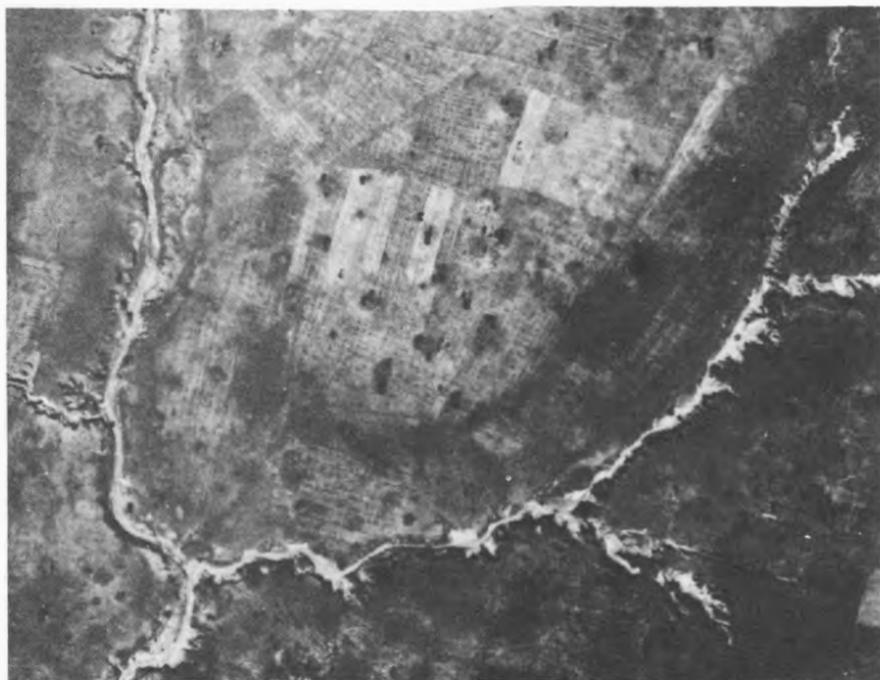
Plate 3: LINEAR GULLY SYSTEM 1:12 500

channels coalesce. Secondly, there are ten distinctly linear gullies (Plate 3), these being relatively narrow channels with very few lateral headcuts (Ireland *et al.*, 1939). Thirdly, there are three examples of broad, shallow gullies with distinctive bulbous forms (Plate 4). In a detailed study of headcuts on dendritic gully systems Stocking (1978b) recognized five major plan forms (pointed, rounded, notched, digitate and bulbous), these being related to the processes of subsurface and overland flow affecting the headcuts. Similarly, at the scale of the gully system as a whole, the variations in a plan form are likely to reflect dominant processes as well as the nature and depth of the unconsolidated materials within which the gullies are formed. Further field observations are required to verify these points.

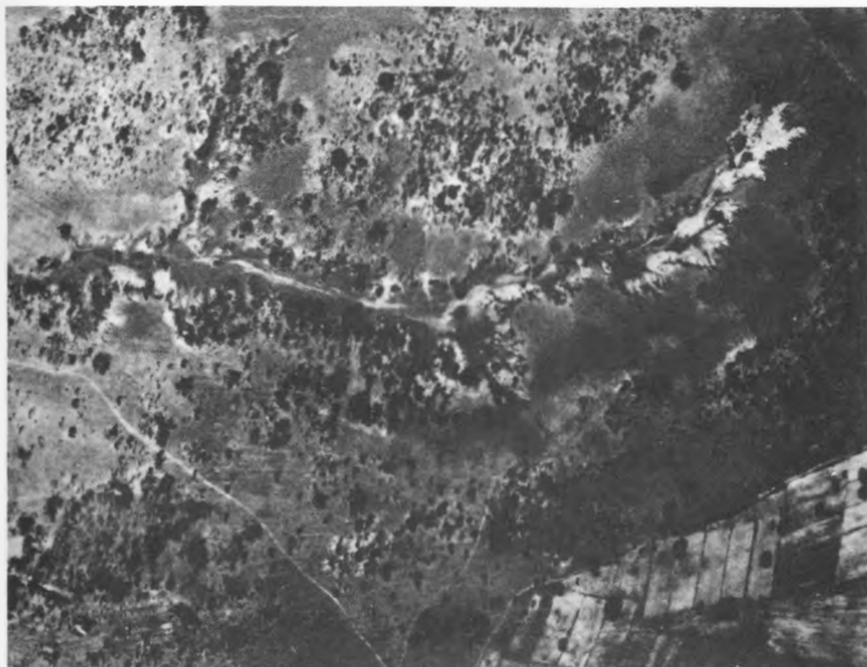
Plate 4: BULBOUS GULLY SYSTEM 1:12 500

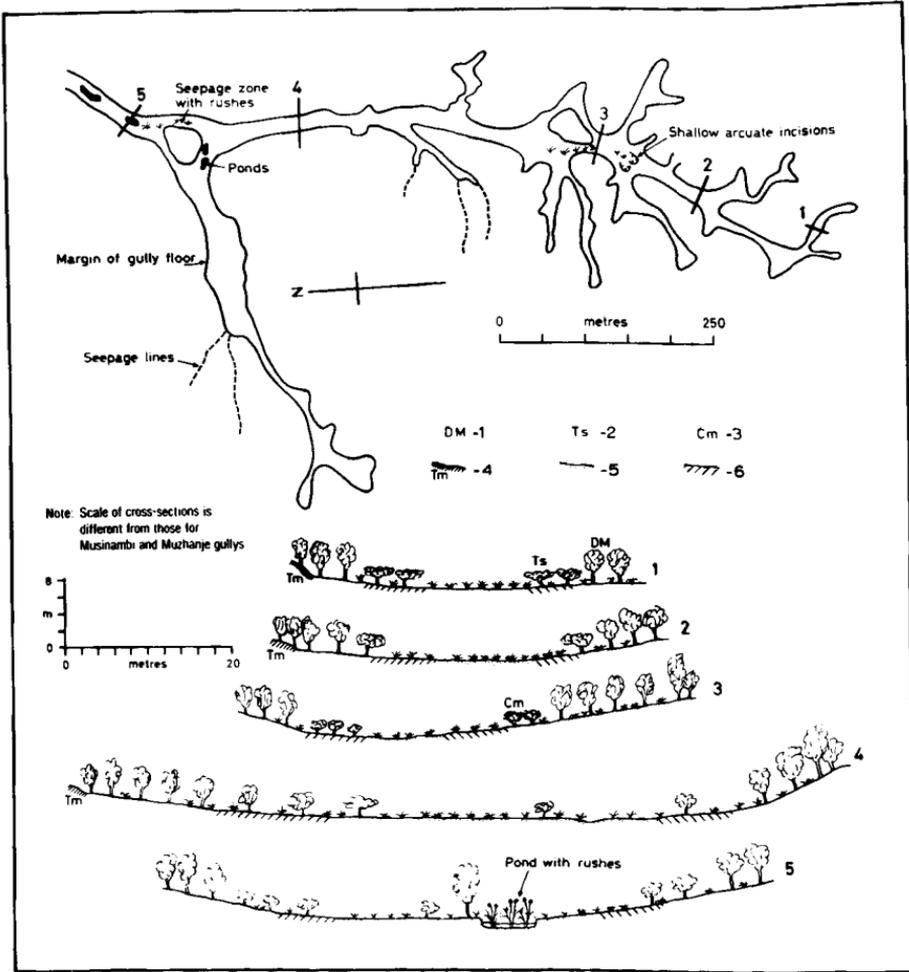
Figure 2: MORPHOLOGY OF MANYEWE GULLY

Manyewe Gully: This was selected as an example of a stabilized gully, now choked with sediment, in the lower Muzveze basin. The outline plan of the gully (Fig. 2) defines the junction between the relatively flat gully floor covered in dense herbaceous vegetation, a vivid red colour on the false colour imagery, and the adjacent sparsely-wooded degraded slopes. The gully system is 2 810 m in length, up to 6 m in depth and, using the basal width of the infilled floor, between 6 and 42 m wide. The former headcuts have a distinct broad lobate form and are distinguished on the ground mainly through contrasts in vegetation rather than

clear breaks in slope. For example, the fringes of the gully floor are characterized by a narrow (3–8 m) zone of stunted, frosted shrubs, mainly *Terminalia sericea* and *Colophospermum mopane* (Fig. 2).

Three morphological units could be identified in this stabilized gully — these being degraded slopes, a sheetwash zone and the gully floor. The degraded slopes, lowered through processes of sheetwash and rilling, were characterized by a dry miombo woodland dominated by *Brachystegia* spp., very similar to that in areas surrounding the gully. The upper margins of these slopes were poorly defined, but generally convex in form. Slope angles (see sections 1–5 in Fig. 2) were generally between 8° and 12° along the main gully, although locally much greater. Extensive areas of bare ground are exposed beneath the discontinuous tree canopy, and numerous calcareous nodules 1–2 cm in diameter occur on these denuded surfaces. The bases of these degraded slopes are sometimes marked by a clear break in slope with the lower sheetwash zone. More commonly, however, deposition of sheetwash material gives rise to a gradual change in slope on rather hummocky ground.

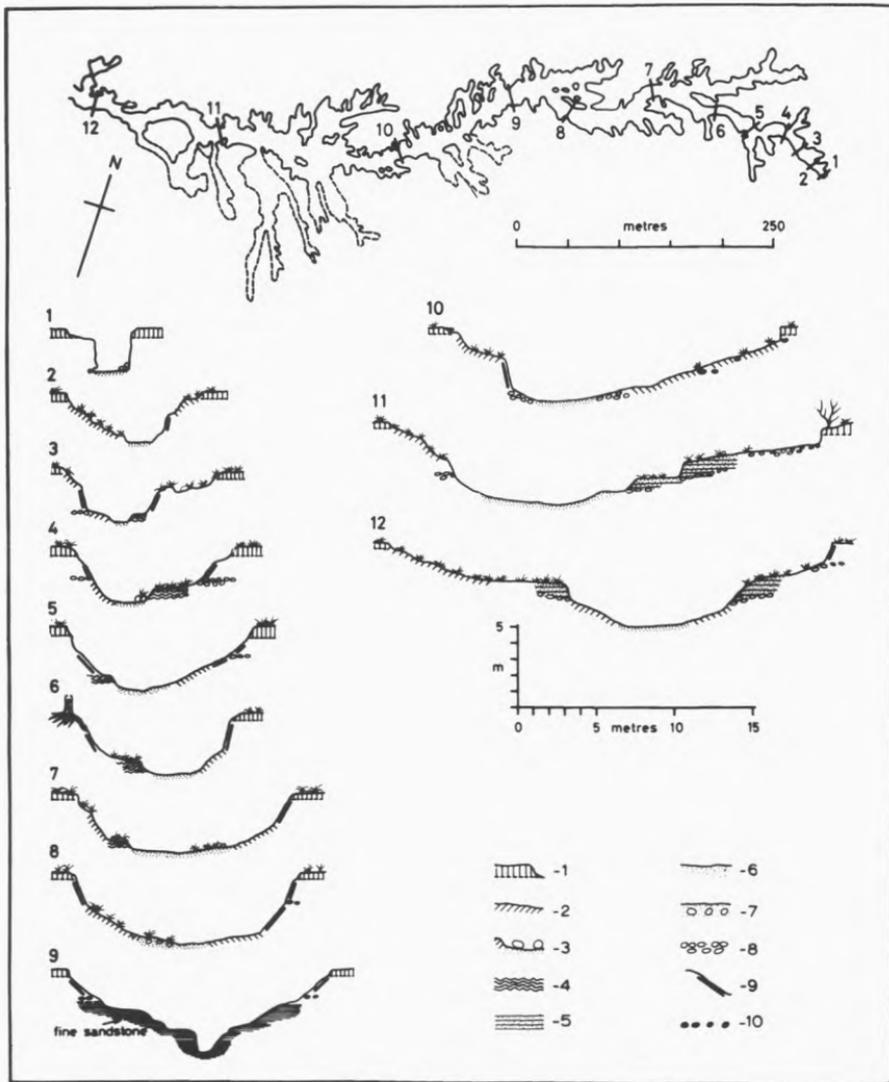
Figure 3· MORPHOLOGY OF MUZHANJE GULLY

Muzhanje Gully: This was selected as a relatively simple example of a deep, active gully system. Twelve cross-sections were surveyed in the upper reaches of this gully over a length of 720 m, with more general observations being made in the remaining 630 m of the channel (Fig. 3).

This incised channel is eroded into deep colluvium within which there are clearly developed discontinuous stonelines. Stocking (1978c) interpreted these as lag gravels buried by colluvium which is up to 3,5 m deep in this particular gully. The upper 1 m of the colluvium forms a distinct layer that probably originated from sheetwash erosion (Fig. 3), but this origin requires further study.

Six profiles were surveyed within 120 m of the headcut on the basis that these would show evidence of more recent (last 200 years) gully extension. The headcut itself is 2,8 m deep and 2,2 m wide with a 'square' plan form. A shallow, discontinuous channel drains into the headcut and most of the surface horizon above the incision has been stripped away (Plate 5). At the base of the headcut there is evidence of lateral undercutting associated with piping (Fig. 3). The sections directly below the headcut are essentially U-shaped with a flat floor covered in recently deposited sediments. Differential erosion of the friable sheetwash material and localized mass movements have resulted in irregular hummocky and stepped gully walls, with the steeper banks (over 40°) being characterized by fluting. There is a terrace-like feature some 0,8 m above the present floor in this upper reach of the gully (Plate 6). It is composed of poorly stratified sediments which could have been produced from materials derived from sidewall erosion rather than movement down the channel. It suggests a recent phase of localized entrenchment of the gully of up to 1,5 m into infill deposits that extend 0,5–0,7 m below the present gully floor.

Below the junction of a major right-bank tributary, the main gully widens appreciably to about 13,5 m at section 7, but does not exhibit a comparable increase in depth (Fig. 3). There is still evidence of a terrace feature in this portion of the gully. Further downstream (section 8) the gully increases to a width of 14,4 m and a depth of 4,4 m and the banks are strongly fluted with numerous pipe outlets entering the gully about 2 m below the ground surface. This part of the gully is extremely dissected due to the coalescence of several right-bank tributaries. Vertical incision has exposed the well-jointed, partially weathered Karoo sediments (Plate 7) in the basal 3 m of section 9 and for 80 m either side of this section. Channel erosion has exploited the vertical joints in the Karoo sandstone forming a cleft 1,3 m deep and 1–1,2 m wide in the base of the channel (section 9, Fig. 3).

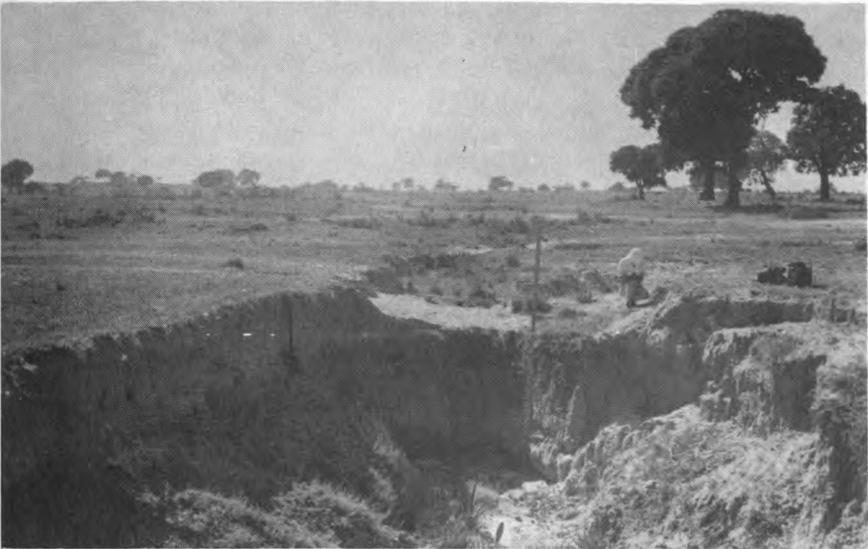
Plate 5: MAIN HEADCUT ON MUZHANJE GULLY WITH HANDLE OF SPADE MARKING THE SUSPECTED SHEETWASH HORIZON

The gully is incised in a gently sloping valley floor (Plate 5), with generally well-defined, somewhat irregular margins due to the existence of numerous small lateral headcuts. Coalescence of active headcuts in the past has left a series of residual ridges and knolls (Fig. 3), between sections 8 and 10, for example. There are also several large subsidence hollows, over 2 m in diameter, near the gully upstream of section 8 and these emerge as pipes at various levels in the walls of the gully below section 7. Downstream of section 9 several shallow lateral gullies drain into the main channel, but these are well vegetated and have poorly defined margins.

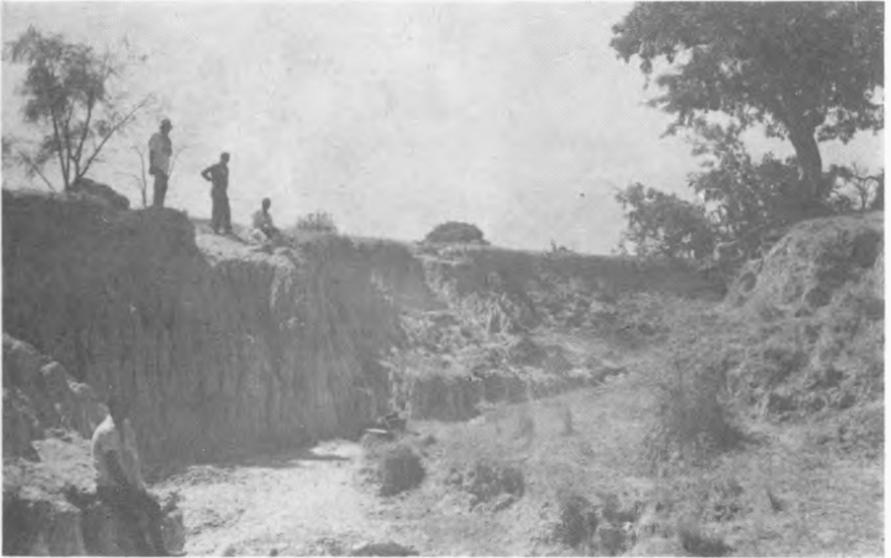
Plate 6: FLUTED VERTICAL BANK AND RESIDUAL BENCH BELOW SECTION 6, LOOKING UPSTREAM

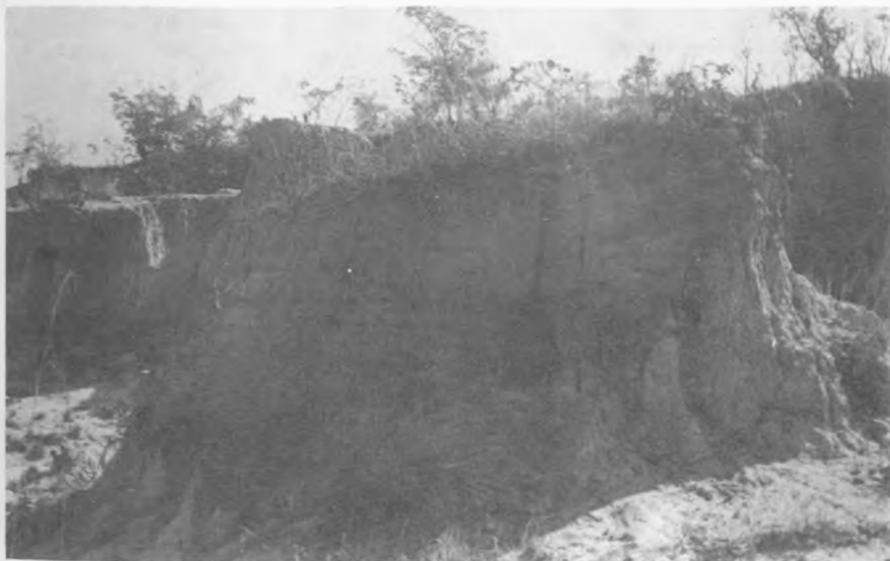
Plate 8: STRATIFIED INFILL IN LOWER REACHES OF MUZHANJE GULLY

distinctive benches between 2,2 and 2,8 m above the present gully floor (Plate 8). These sediments comprise intercalated humic and mineral horizons which are generally underlain by a coarse gravel layer of mainly siliceous nodules. These terraces seem to have been produced as a result of deposition in a broad, flat channel with localized fans from lateral gullies. Below section 12 the gully has near vertical walls up to 8 m deep and a very flat floor, this form being typical of the lower reaches of gullies in this area. However, remnants of the infill terraces persist, sometimes on both sides of the channel, for some distance below section 12.

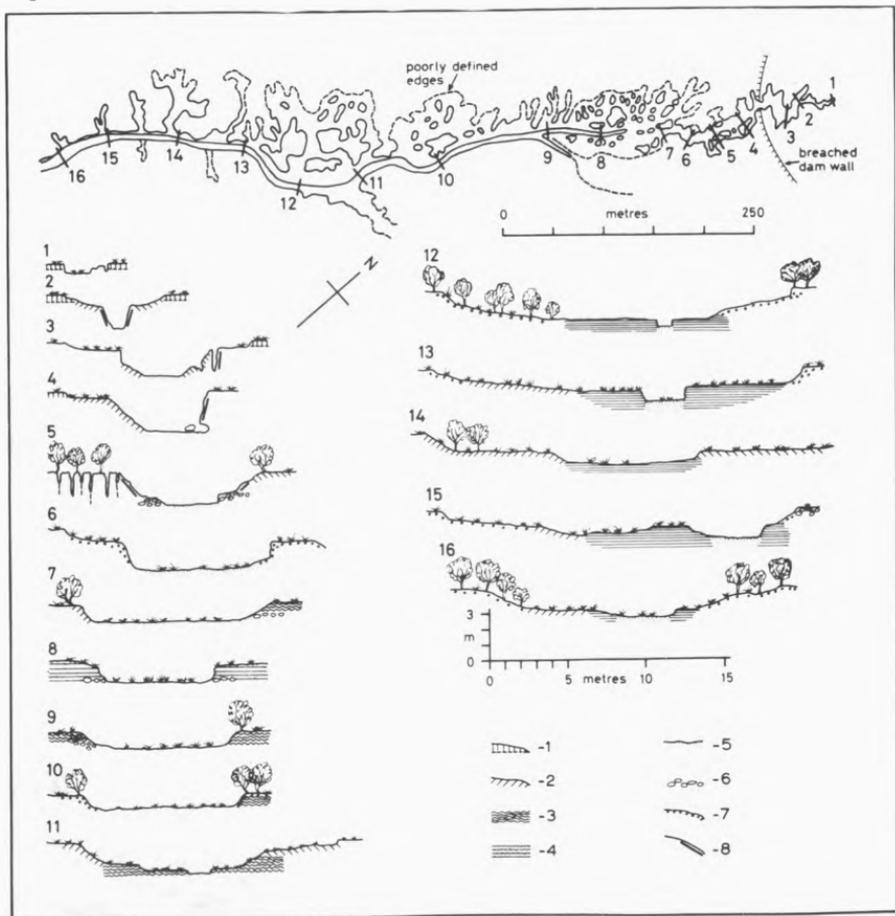
Figure 4: MORPHOLOGY OF MUSINAMBI GULLY

Sixteen cross-sections were surveyed along this gully as shown in Figure 4. For discussion purposes these can be divided into three groups, these being a zone of

incision (sections 1–6), a zone of deposition (sections 7–10) and zone of entrenched infill (sections 11–16). Below section 5 the cross-section surveys were restricted to the inner portion of the gully because of badland erosion extending 30–80 m back from the main axis of the gully. Wherever possible the sections were located where intact remnants of the former ground surface existed, avoiding severely eroded banks. A series of photographs was selected to demonstrate variations in morphology and infill sediments in this gully (Plates 9–12).

Section 1 (Fig. 4) is at the head of the gully where there is a broad rounded headcut some 0,8 m deep. Subsurface piping is evident at the base of the fine sandy A-horizon and appears to be a major cause of headcut enlargement. Some 30 m downstream of this there is an incision 1,4 m deep and 1,7 m wide, with near vertical, fluted walls (section 2, Fig. 4), giving rise to a clear gully-in-gully form (Plate 9). The subsoil material which has been incised is pale grey-brown in colour with localized iron mottling and a distinctive prismatic structure, typical of the weathered Karoo sediments. Below the inner gully headcut the channel widens rapidly to about 6 m and at section 4, below the breached dam, is nearly 2,5 m deep. Deep vertical clefts and pipe outlets up to 0,35 m in diameter, along with loose fresh debris and blocks of soil on the gully floor, show that there is very active erosion, mainly subsurface in nature, in this reach of the gully. Small (under 0,1 m diameter) holes are present up to 35 m away from the outer gully banks and

indicate the existence of an extensive pipe network. Subsurface tunnelling could well have caused the breaching of the dam wall between sections 3 and 4 (Fig. 4).

Sections 5 and 6 represent a more advanced stage of widening of the gully. Massive siliceous nodules at the base of the gully at section 5 form distinctive steps in the gully wall and have inhibited basal widening. However, erosion of materials overlying the nodules has given rise to lower angled ($45\text{--}50^\circ$) slopes, with numerous deep vertical clefts on the left bank and rounded cavities providing evidence of active subsurface erosion. There is still some sign of the gully-in-gully form at section 6 (Fig. 4), with the inner channel being nearly 9,5 m wide and 1,8 m in depth. Stripping away of the surface soil has exposed material packed with calcareous nodules, 1–2 cm in diameter, which in section display a series of concentric rings, suggesting gradual accretion in a weathered substrate. There is still loose, fresh sediment on the gully floor at this site, but now with a sparse cover of stoloniferous grasses.

Sections 7–10 represent a zone of deposition within the inner gully system which itself is incised into infill sediments (Fig. 4). The channel is rectangular in section and about 7,5–12 m wide and about 1 m in depth, with a well-grassed flat floor (Plate 10). Either side of the gully the surface soil has been removed completely giving rise to a series of residual knolls and ridges, especially on the

The third reach of the gully, the zone of entrenchment, is in the order of 1.5–2 m in depth, up to 23 m wide and very irregular in cross-sectional form (Fig. 4). There is a well-defined trench about 1 m deep and up to 3 m wide in the gully floor (Plate 11), beginning with a narrow, vertical headcut at section 12 and extending for some 80 m down the centre of the infilled channel. The trench becomes progressively shallower downstream of section 13 until it eventually disappears. The remaining sections, 14–16, show signs of successive reworking of infill sediments which has left a very hummocky channel floor. The entrenched sediments were clearly stratified (Plate 12) with several thin humic bands separated by fine, convoluted layers of fine sandy clays indicative, perhaps, of gradual accretion of material. Shallow, elongated troughs upstream of the present headcut at section 11, for example, suggest that there is an element of subsurface erosion taking place within the infilled gully floor. The main cause of headward migration of the trench appears, however, to be overland flow.

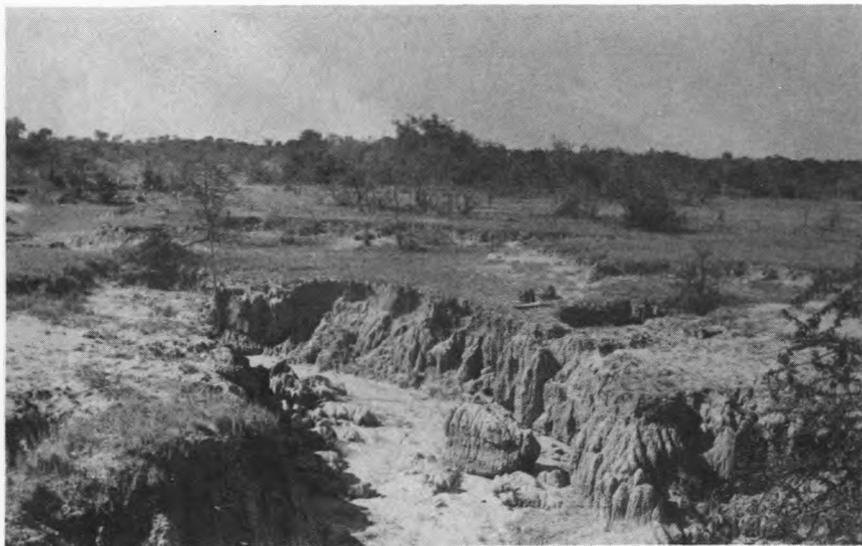
Plate 9: GULLY-IN-GULLY FORM OF THE UPPER REACHES OF MUSINAMBI GULLY

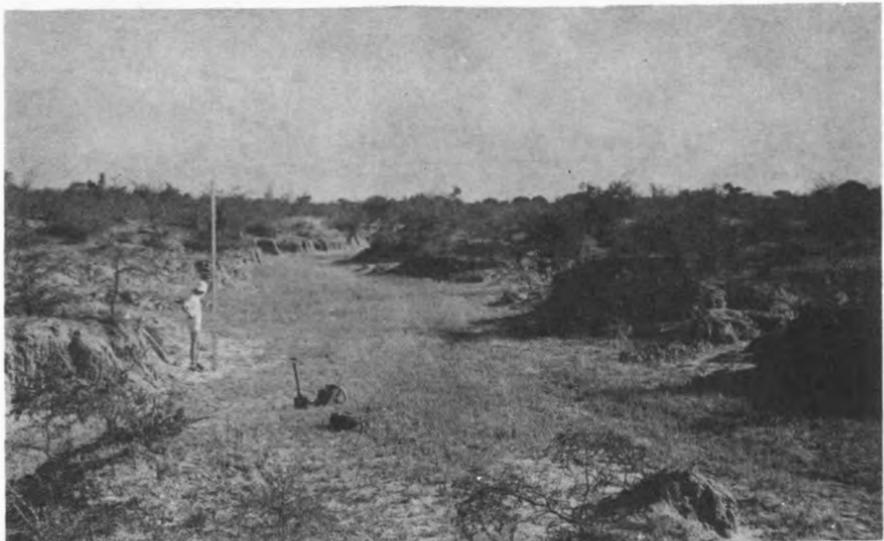
Plate 10: CHANNEL INFILL IN MIDDLE REACH OF MUSINAMBI GULLY
LOOKING DOWNSTREAM WITH C. FIRTH AT POSITION OF
SECTION 7

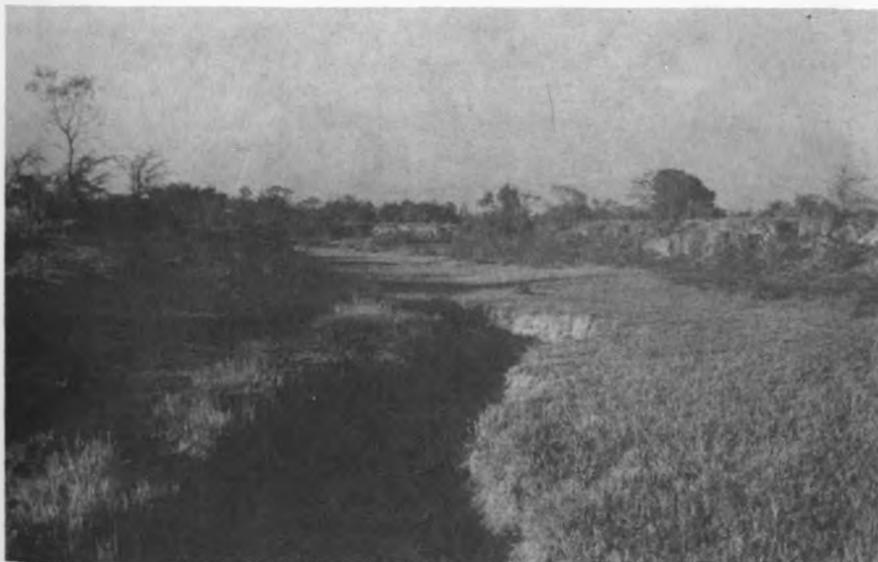
Plate 11: ENTRENCHED INFILL IN LOWER REACH OF MUSINAMBI GULLY, LOOKING UPSTREAM TOWARDS HEADCUT AT SECTION 12

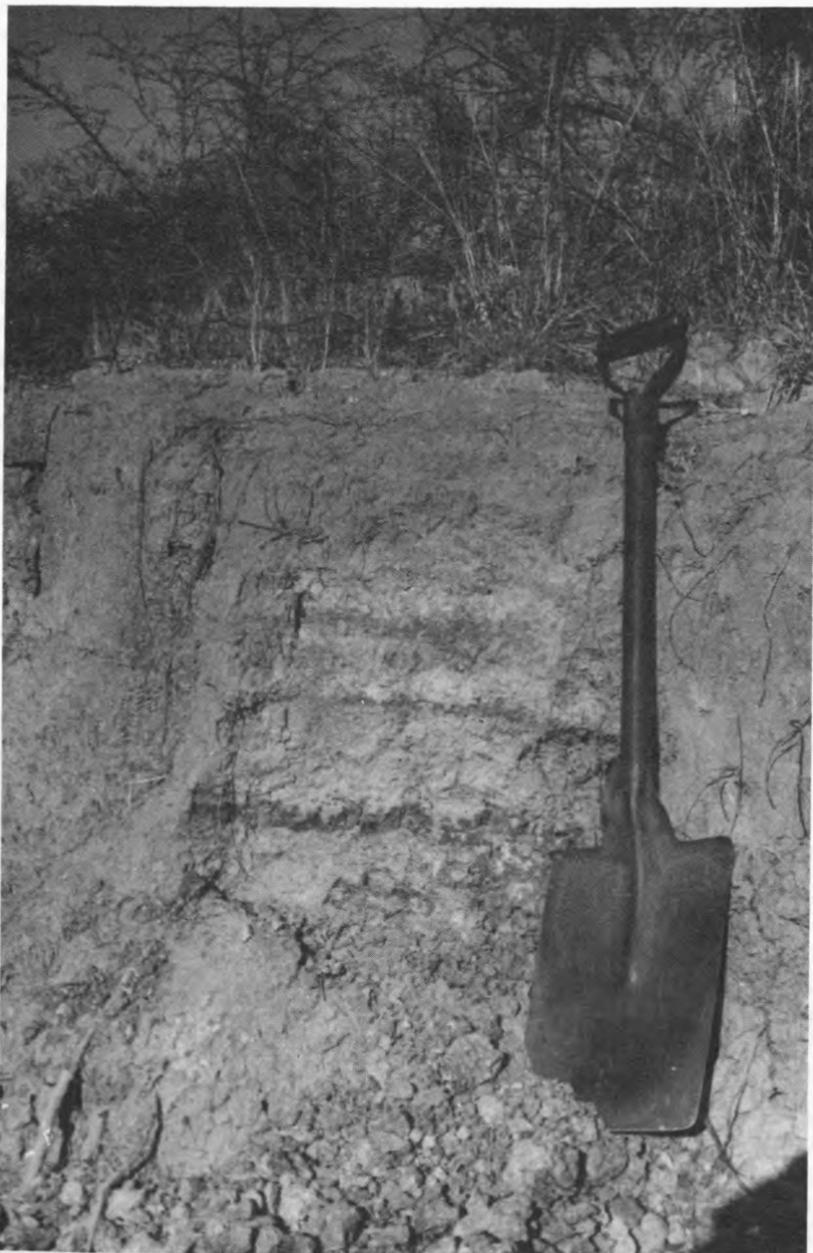
Plate 12: STRATIFIED SEDIMENTS IN ALLUVIAL INFILL NEAR SECTION 12

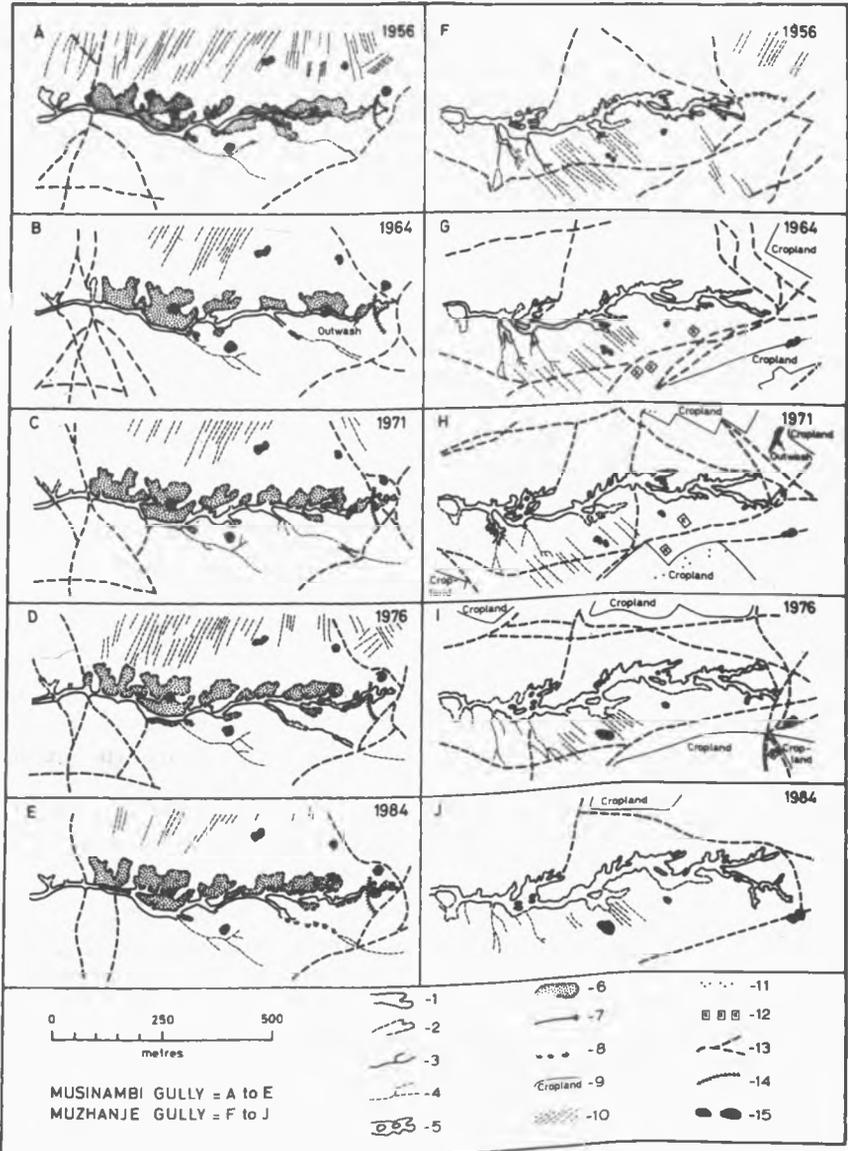
Figure 5: PLAN FORM CHANGES IN MUSINAMBI GULLY AND MUZHANJE GULLY, 1956-1984.

Muzhanje Gully: The changes in plan form of this gully are shown in Figure 5F–J and details on the gully margins and the two main headcuts in the upper part of the gully are summarized in Tables II and III, respectively.

1970s (Fig. 5G, H and I). Extension of croplands at the expense of grazing areas certainly contributed towards growing pressures upon and accelerated degradation of valley sites in the Communal Lands during these years (Cleghorn, 1966; Whitlow, 1979). As a result of this erosion, peasant farmers since Independence (1980) have been persuaded to abandon fields close to gullies as shown here for Muzhanje Gully (Fig. 5J). This may slow down but is unlikely to prevent further growth of this gully.

The left bank, allowing for the exclusion of the stabilized tributary gullies mentioned earlier, is more regular than the opposite bank with relatively low SR values between 1,21 and 1,31 (Table II). Over the 1956–84 period the left bank increased in length by only 178 m, mainly owing to the development and extension of two tributary gullies in the upper reaches of the main channel. The lower of these tributary gullies was poorly defined on the 1976 and 1984 aerial photographs (Fig. 5I and J) owing to the excessive trampling by cattle.

In contrast, the right bank is much more sinuous with SR ratios between 1,88 and 2,47. This is mainly because of the occurrence of three large tributary gullies and numerous smaller lateral headcuts along this bank. The gully margin increased in length by 682 m over the period 1956–84 with the extension of these side channels, and the resulting increased irregularity of the margin is shown by an increase of 0,59 in the SR value. The slight decrease in the length of the right bank in 1976 can be attributed to coalescence of headcuts, leaving isolated ridges and knolls within the main gully (Fig. 5I).
